# Are our mattresses too short for our beds?

The occurrence of heel pressure ulcers appear to not be reducing at the same rate as those in other anatomical locations. May this in some part be due to the standard hospital equipment (i.e. profiling bed frame and standard foam replacement mattress), in daily use in most clinical settings? In an environment where harm-free care is a major focus, it may be time to revisit the equipment that a large number of patients are cared for on.

JACQUI FLETCHER  
Clinical Strategy Director, Welsh  
Wound Innovation Centre,  
Cardiff, UK

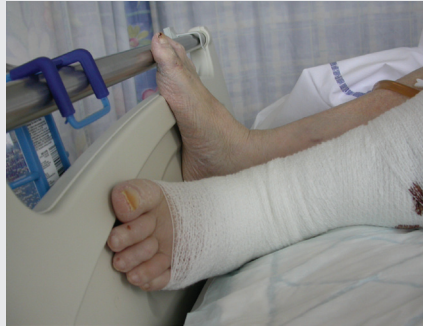
Figure 1. Patient's feet pressed firmly against the bed frame.

However, widespread adoption of these frames has introduced an additional and, so far, unresolved complication. Articulating the bed frame with the patient *in situ* causes the patient's heels to move across the mattress — causing friction and shear forces. Furthermore, while it may seem strange, the articulation of the bed frame makes the bed (and mattress) shorter in proportion to the patient. This frequently results in a mattress that is so short, the patient's heels are not supported and, of even more concern, the feet are being pressed up against the rigid bed end, thus causing pressure damage (Figures 1 and 2).

Furthermore, as can be seen in *Figures 1 and 2*, there is not a huge gap between the end of the mattress and the foot of the bed, so staff are relied on to extend the end of the bed, which they

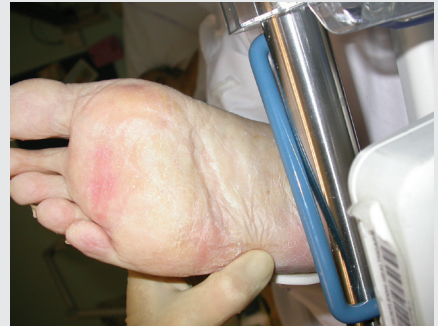
Figure 2. Indentation in the foot caused by pressing against the holder of an alternating mattress pump.

Conversely, as the body profiles to the mattress it appears to become taller (see *Figures 5 and 6*). Therefore, the body may now be longer than the mattress. This means that the heels have been forced over the surface of the mattress causing both friction and shear — on average travelling 15cm (Fletcher 2014). The patient's heels now may be over the end of the mattress and, therefore, not benefiting from any pressure-reducing properties of the equipment. The toes, midfoot or heel may also be firmly pressed against the bed end, causing additional high pressure (see *Figure 2*).

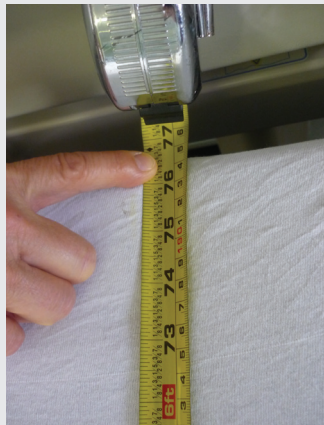
Figure 3. Mattress measured when flat = 195 cm.

Some simple observations have been recorded that may contribute to these issues. A standard hospital mattress is approximately 195 cm long when flat (see *Figure 3*). However, many are now

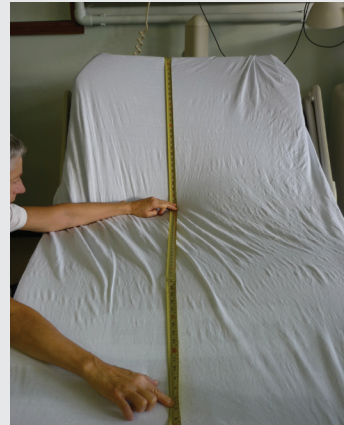
Figure 4. Mattress measured contoured = 186 cm.

used on profiling beds, which means they have to conform to the contours of the bed frame and so are no longer flat. Profiling the mattress across the curves reduces the length of the mattress (see *Figure 4*). In addition, when the bed is profiled with the patient *in situ*, because the mattress moves across the frame, the patient's heels move between 15–20cm across the surface.

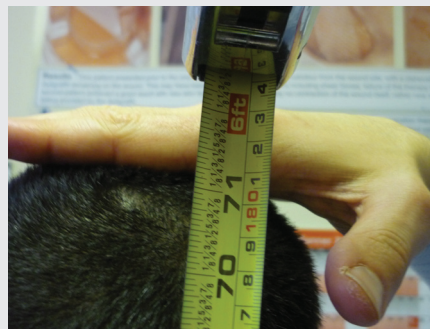
Figure 5. Man measured when standing = 181 cm.

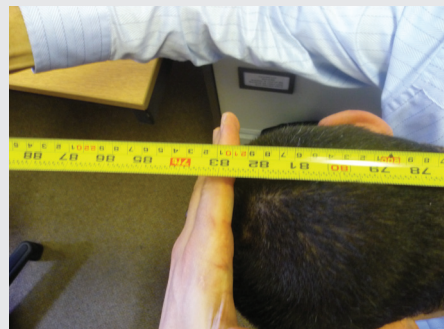
Figure 6. Man measured when reclined = 210 cm.

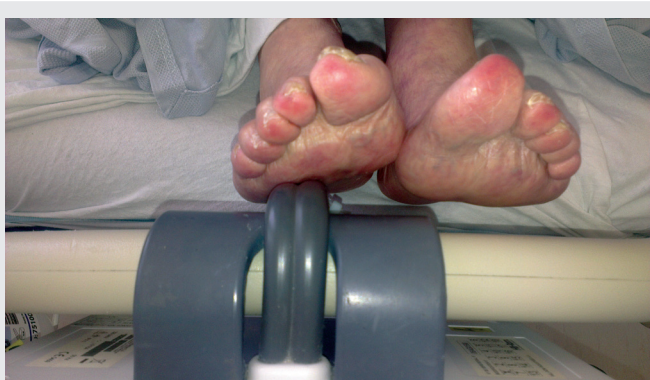
Figure 10. Equipment hung on the bed end potentially causing pressure damage.

frequently forget to do and which may compromise space in already tight bed areas. In addition, the issue of using the bed end to hang a whole variety of things on, including mattress boxes and plastic folders that hold the patients' notes, also increases the risk (see *Figure 10*). Staff can seem oblivious to this perhaps because it occurs so commonly.
