The use of the Versatile I Wound Vacuum System to treat a patient with a challenging grade 3 pressure ulcer in continuing care

John Timmons is Tissue Viability Nurse, and David Gray is Clinical Nurse Specialist, Department of Tissue Viability, Grampian Health Services, Aberdeen

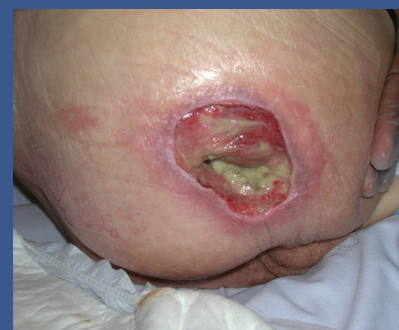
Figure 1. The grade 3 pressure ulcer on day one of the VI therapy.

On day one of treatment, the wound measured 6cm wide x 4cm long x 4cm deep (Figure 1). On examination, the wound showed no signs of clinical infection and the wound bed was covered with a mixture of granulation tissue and slough, which was adhered to the base and filled the cavity. The VI pump was applied at a setting of 80mmHg and left on continuous suction, with dressing changes taking place every 3–4 days. By Day 8 (Figure 2) of treatment, the wound measured 5cm x 4cm x 3.5cm with no evidence of infection. The wound had undergone a reduction in the amount of slough present, and there was evidence of contraction at the wound margins. On Day 24 (Figure 3) of VI therapy, the wound measured 4cm x 4cm x 2.5cm. The wound bed consisted of 100% granulation tissue with no signs of clinical infection. At review on Day 50, the wound had made sufficient progress to healing so treatment with the VI Pump was discontinued (Figure 4). The wound dimensions were 2cm x 1.5cm x 1.5cm; with 100% granulation tissue noted on the wound bed, and no evidence of clinical infection.

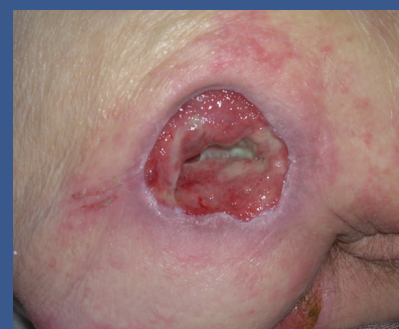
Figure 2. By Day 8 of treatment a reduction in wound dimensions and amount of slough is evident.

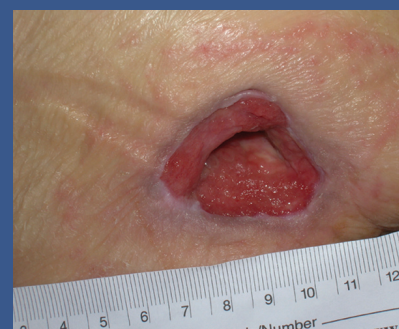
Figure 3. By Day 24, the wound bed was covered in 100% granulation tissue.

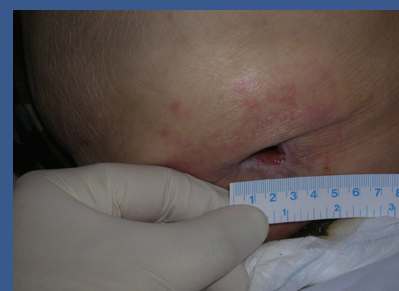
Figure 4. On Day 50, the wound had suitably progressed to healing, so VI therapy was discontinued.
